FINAL
QUINAULT ESTATES DRAINAGE INVESTIGATION

Volume I - Text

December 1993

R.W. BECK
AND ASSOCIATES

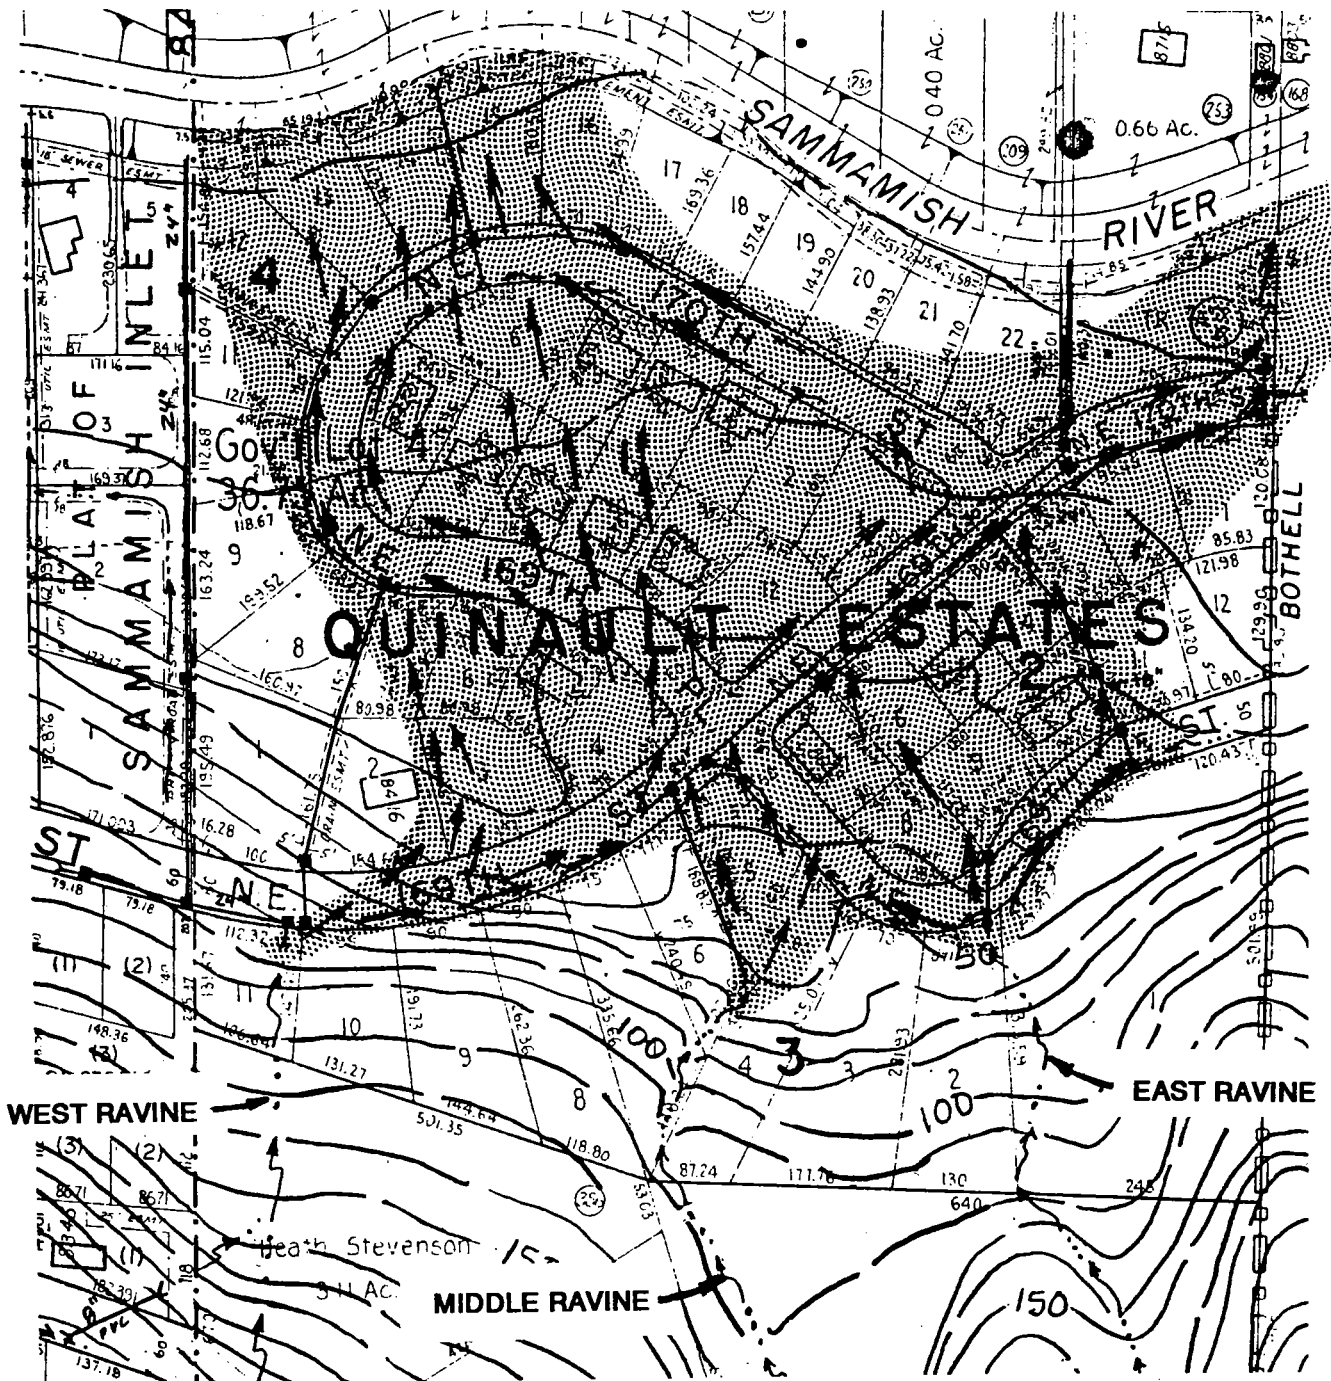
FIGURE 3
KING COUNTY
SURFACE WATER MANAGEMENT DIVISION
QUINALT ESTATES STUDY
HISTORIC PROBLEM AREAS

APPROXIMATE AREAS OF HISTORIC FLOODING AND/OR SEDIMENT DEPOSITION PROBLEMS. ARROWS INDICATE APPROXIMATE FLOW PATHS DURING FLOODING EVENT.

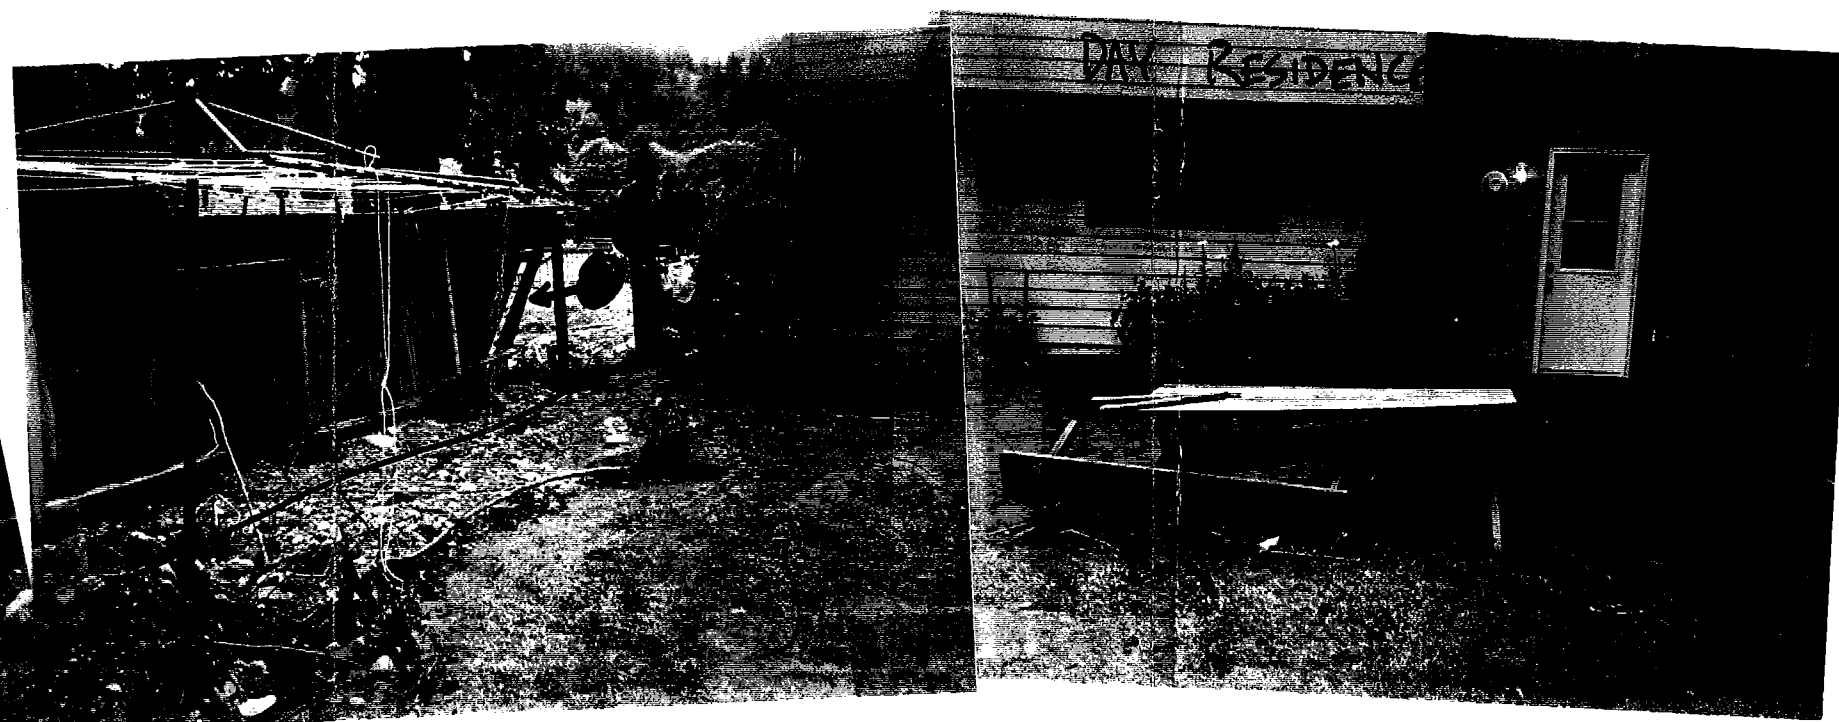
PHOTOGRAPH 1

PROBLEMS

1. LARGE VOLUMES OF SEDIMENT AND DEBRIS CAUSES PLUGGING AT INLET
2. INADEQUATE INLET CAPACITY EVEN WITHOUT CONSIDERATION OF SEDIMENT LOAD
($Q_{inlet\ cap} = 22\ cfs$, $Q_{100} = 30\ cfs$)
3. SYSTEM IS PRIVATELY MAINTAINED

STATION 0+00
CULVERT ENTRANCE AT RAVINE BOTTOM
(LOT 4 QUINAULT ESTATES - DIVISION 3, DAY RESIDENCE)
FLOOD AND DEBRIS DAMAGE FROM JULY 13 EVENT

NOTE: LARGER ROCKS AND BOULDERS DEPOSITED IN THIS AREA. FINER MATERIAL DEPOSITED IN THE DOWNSTREAM AREAS.

MIDDLE RAVINE - STATION 0+00
(AT CULVERT ENTRANCE)

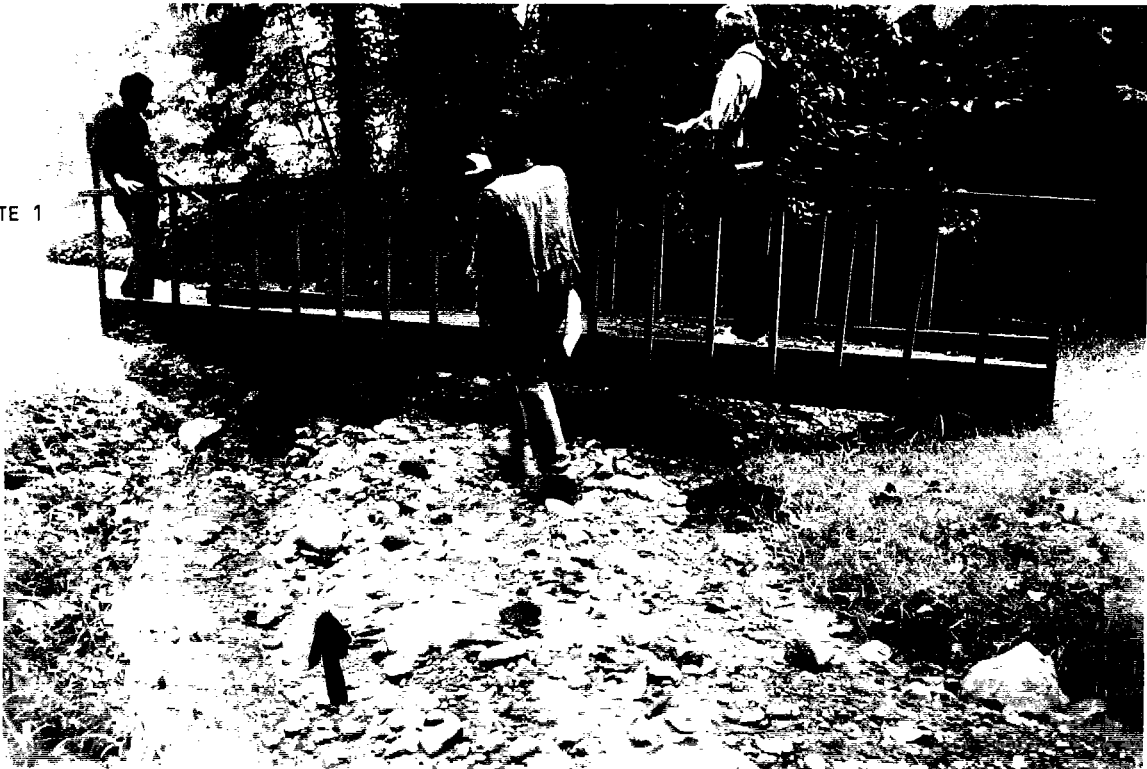
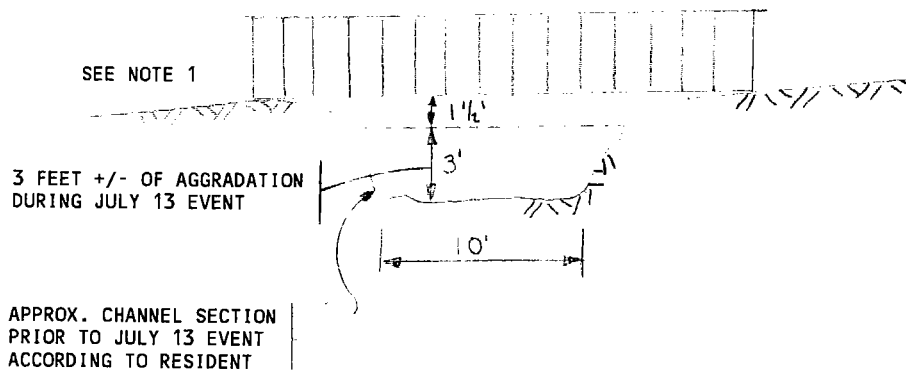
PHOTOGRAPH 3

STATION 1+20
(LOT 7 QUINAULT ESTATES DIVISION 3, READER RESIDENCE)

MIDDLE RAVINE
STATION 1+20
(FOLLOWING JULY 13 EVENT)

REDUCED CHANNEL CROSS SECTION COULD RESULT IN NEW OVERBANK
FLOWS AND FLOODING OF THIS RESIDENCE

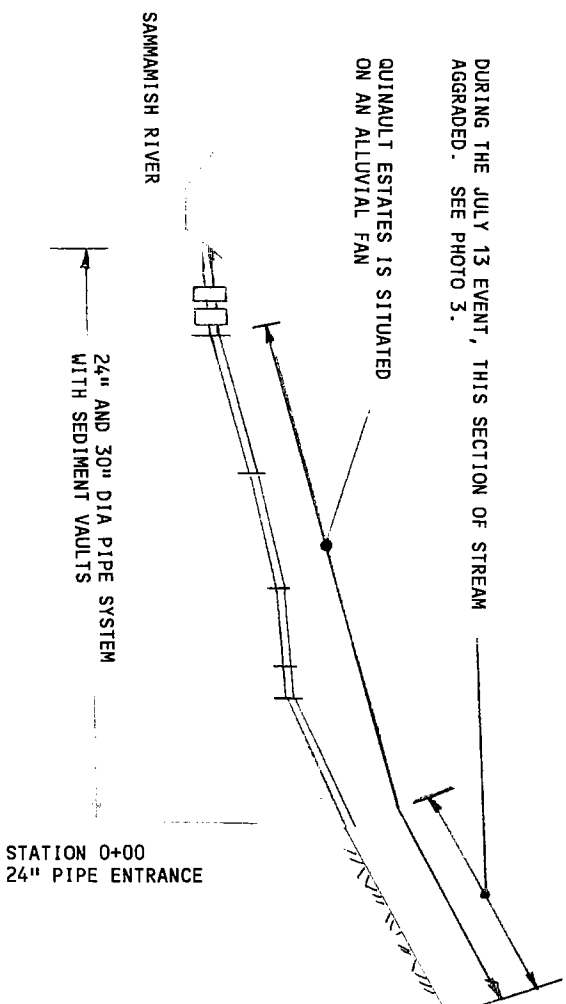
DEBRIS DAM FAILURES RESULT IN DEBRIS
AND SEDIMENT MOVEMENT DOWNSTREAM

DEBRIS DAMS - THESE DAMS RESULT IN DEPOSITION
UPSTREAM AND EROSION DOWNSTREAM

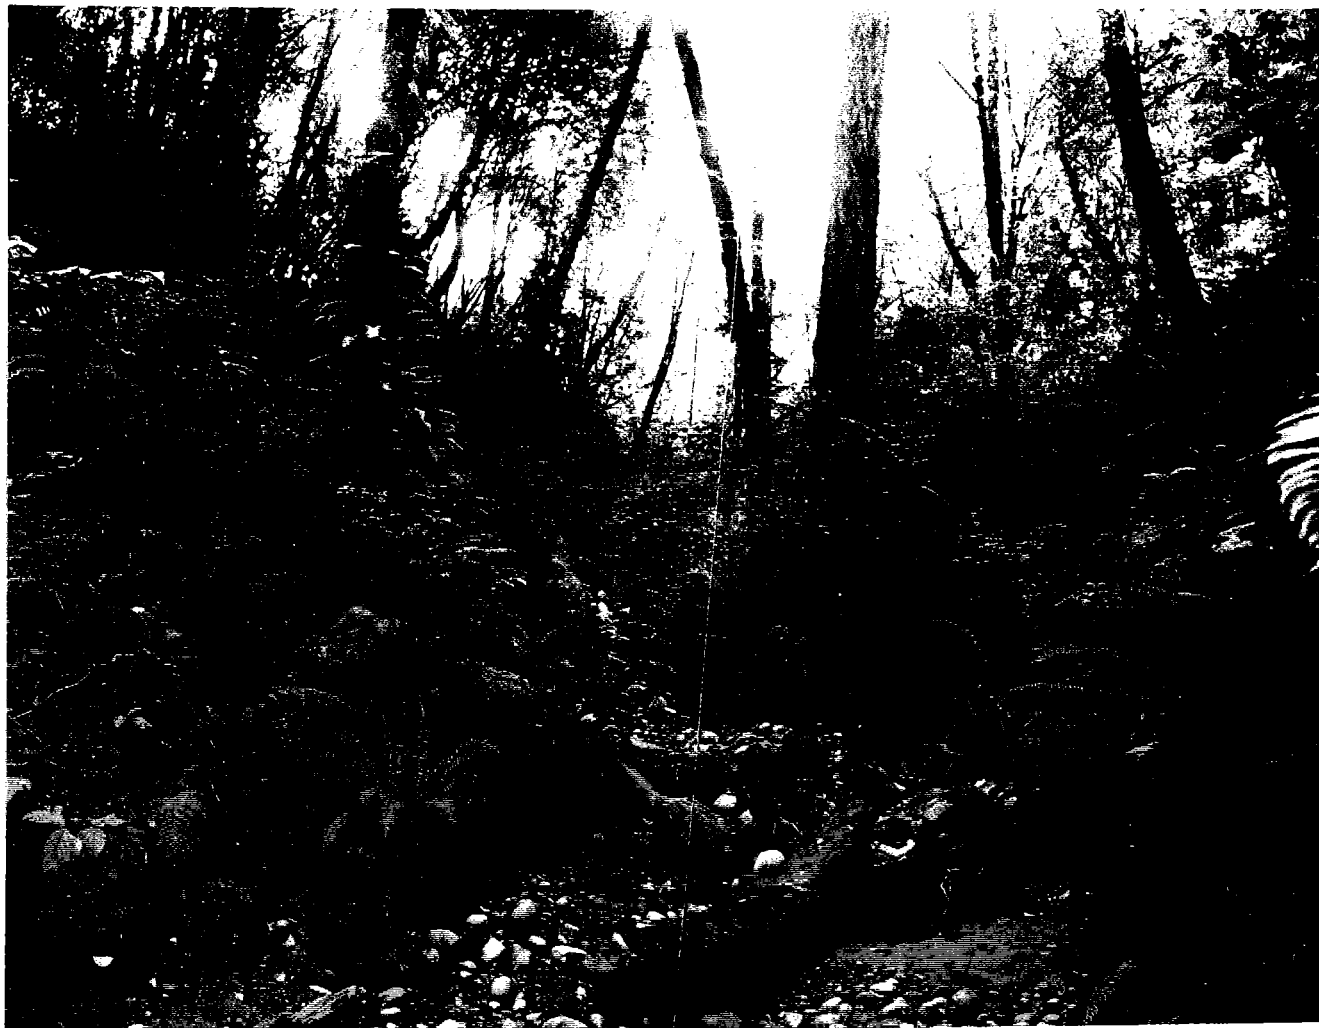
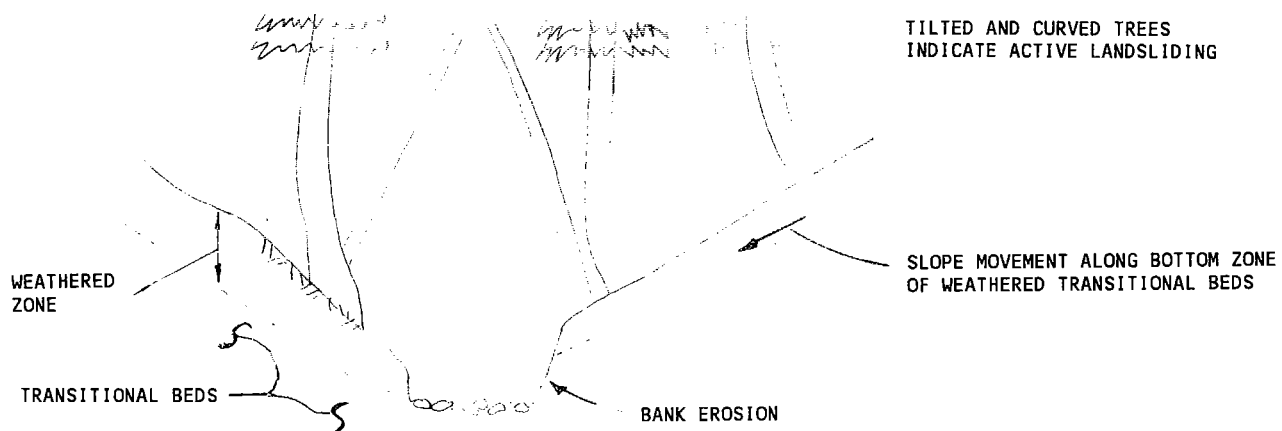
STATION 9+80

NOTE MEN WALKING IN CHANNEL

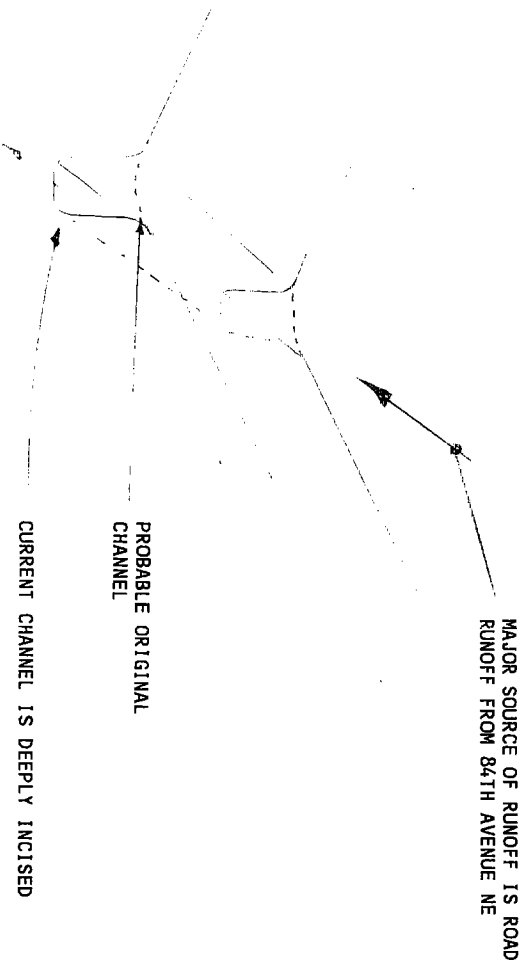
THE CHANNEL IS DEEPLY INCISED
THROUGH TRANSITIONAL BEDS. THIS
INCISION IS OCCURRING ALONG 680 OF THE
830 LF OF CHANNEL, WITH AN AVERAGE
DEPTH OF 5 FT. ORIGINALLY, THIS PROBABLY
WAS A VERY SMALL CHANNEL DRAINING A SMALL
AREA. WITH AN INCREASE IN CONTRIBUTING SURFACE
RUNOFF, CONTINUED SCOUR IS EXPECTED.

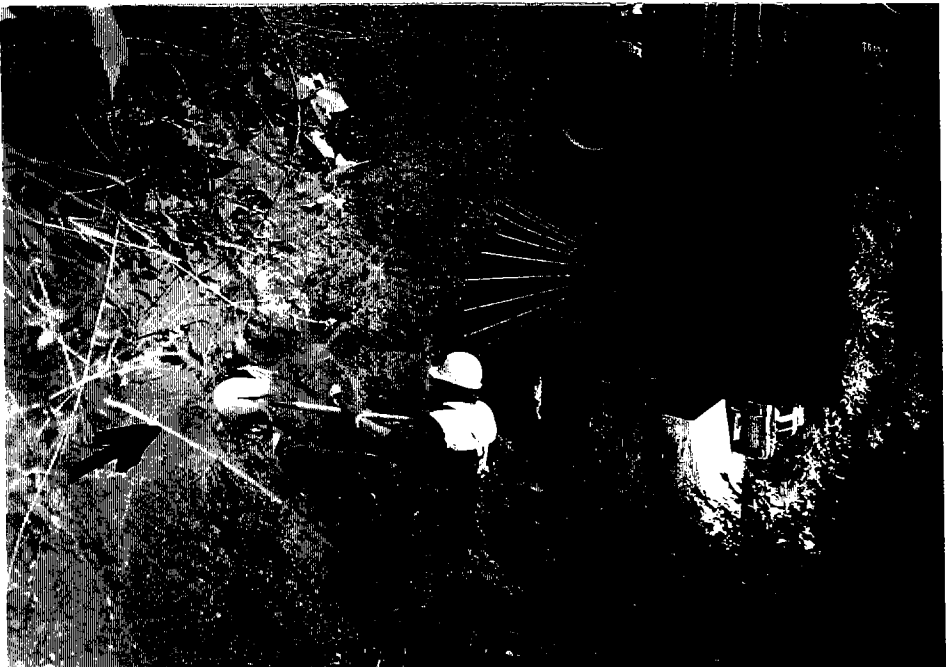
STATION 0+00 - NE 169TH STREET (CULVERT ENTRANCE AT BOTTOM OF RAVINE)
PIPE INLET AT RAVINE BOTTOM (STATION 0+00) IS SUBJECT TO SEDIMENT DEPOSITION AND DEBRIS PLUGGING, RESULTING IN OVERTOPPING OF NE 169TH STREET. CURRENT SEDIMENT TRAP VOLUME IS APPROXIMATELY 10-20 CY.

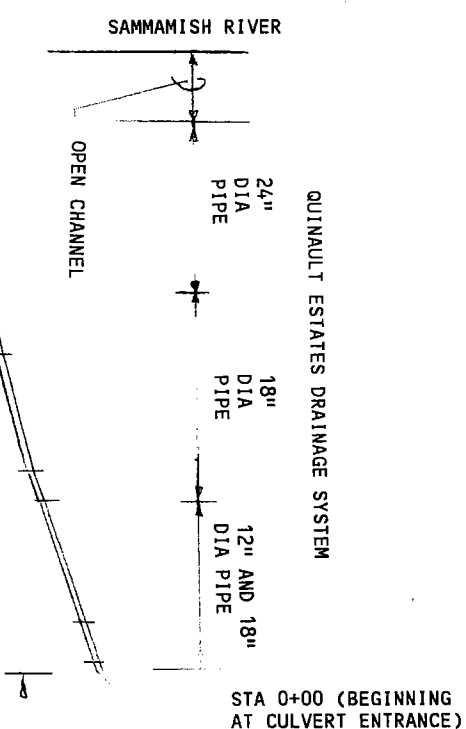
STATION 10+25 - 88TH AVENUE NE BRANCH (UPPER PORTION OF FAILURE)

The most dramatic conditions exist along the 88th Avenue Branch (Photograph 7). From the pipe outfall, the channel has incised about 6 feet for a distance of 175 feet. This incision terminates at a large 3,200-cubic-foot bowl. The failure is a 175-foot-long elongated bowl with a maximum depth of roughly 25 feet and a maximum top width of about 60 feet. The failure was probably formed by several large slides, numerous small slides, frequent surface spalling, and erosion. Large cracks are visible around the top, indicating additional failures could occur. The initial failure occurred in the 1970s, according to court statements of a long-time resident.

Currently, there is a considerable quantity of material from failures resting at the bottom of the bowl that could be easily eroded and transported by runoff. During the field visit in late September, significant groundwater inflow was observed at the lower end of the bowl; this was probably a contributing factor in the initial failures. The original hillslope had a gradient of about 40 percent.
